Interim Wastewater Pond Management Plan
US Magnesium LLC
Rowley, Utah

Submitted to: U.S. Environmental Protection Agency, Region 8

Prepared by: US Magnesium LLC

October 6, 2017

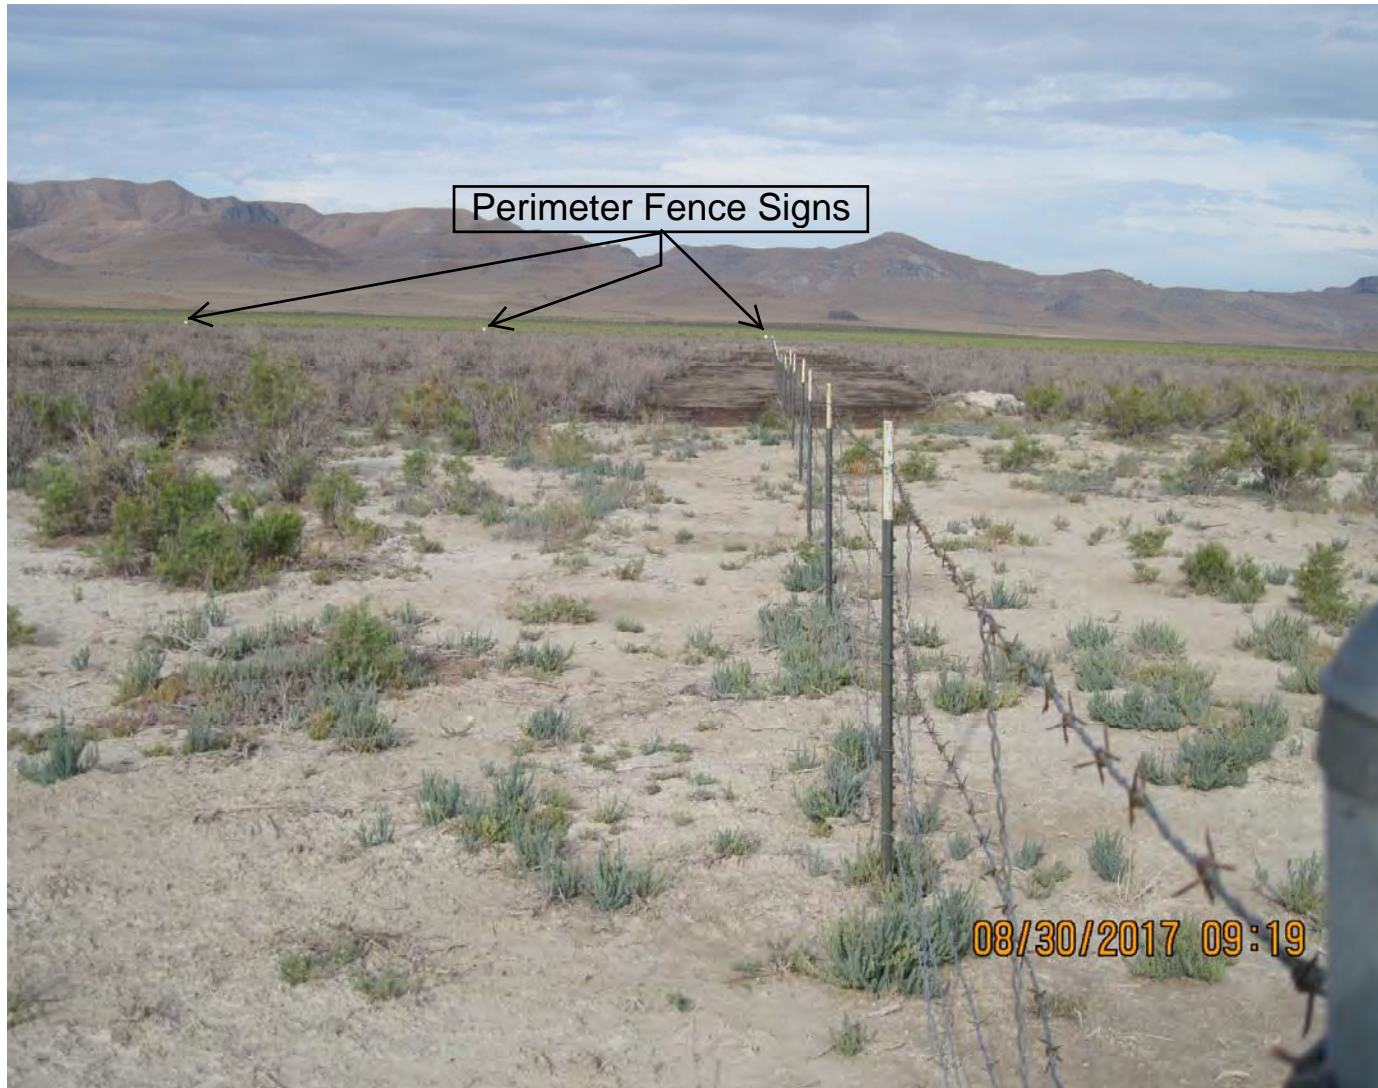
EPA's July 21, 2017 letter also states that "USM must assess the areal extent of the recent release and reconstruct the fence, with warning signs installed under the February 2014 EPA RCRA AOC, to ensure the public is not exposed to acidic water contaminated with chlorinated hydrocarbons." As shown on Photographs 8, 10 and 11 (August 30, 2017), a small pond of residual water remained in the area beyond the northwest embankment (in the Angel Wing area). The residual ponded water was entirely within the existing fenceline and the warning signs remain posted and legible. The warning signs are 9 inches by 12 inches and display "Warning - Keep Out - Hazardous Materials Area Beyond This Point." Photograph 9 (September 28, 2017) shows ponded water within the posted, fenced area, but the ponded water is likely primarily or entirely rainwater that accumulated in this low area. Over the weekend of September 23 and 24, 2017, USM recorded 1-inch of precipitation at the rain gauge located at the plant site. USM anticipates that the measures described in this PMP will prevent any future releases to the Angel Wing area; however, the existing fence and signs will be maintained as originally installed.

Photo 11. Northeast corner of perimeter fence, view toward west
